**FOURTH FIVE-YEAR REVIEW REPORT  
SOLID STATE CIRCUITS, INC. SUPERFUND SITE  
REPUBLIC, GREENE COUNTY, MISSOURI**

**Missouri Department of Natural Resources  
Hazardous Waste Program  
Jefferson City, Missouri**

**U.S. Environmental Protection Agency  
Region VII  
Kansas City, Kansas**

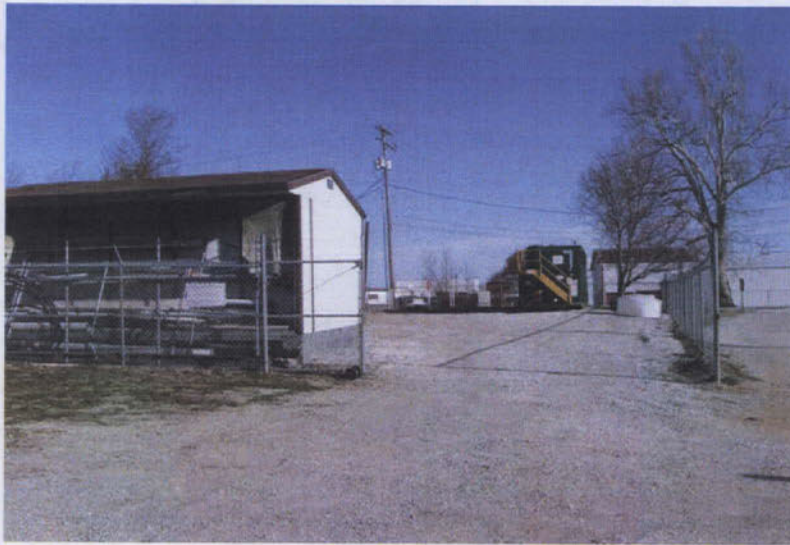
Photograph 1  
Solid State Circuits Site  
Republic, MO  
Photo Taken 03/06/2012 Candice  
McGhee, DEQ/HWP/SPF

View of open entrance gate with  
remaining outbuilding and Baker  
tank. Photo taken Facing North  
into SSC site.

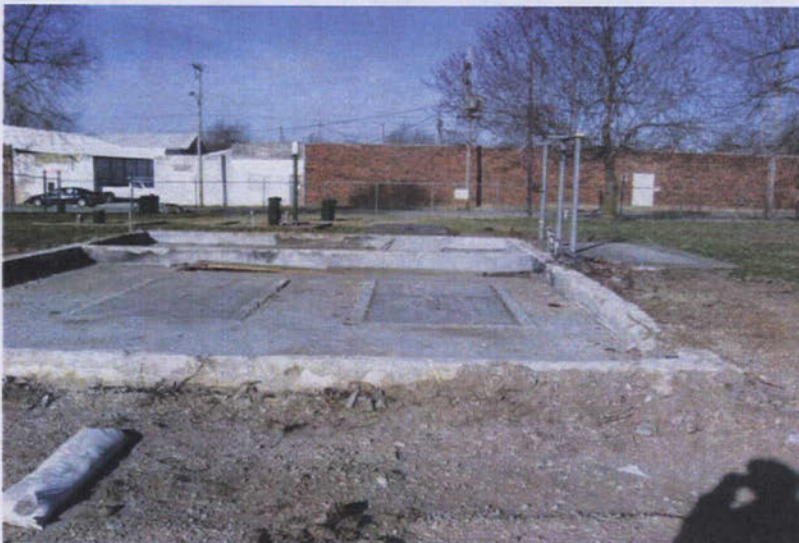
Photograph 4  
Solid State Circuits Site  
Republic, MO  
Photo Taken 03/06/2012  
Candice McGhee,  
DEQ/HWP/SPF

View of treatment facility concrete footprint, utility lines and on-site wells (1 of 2). Photo taken Facing West across SSC site towards Main Street.

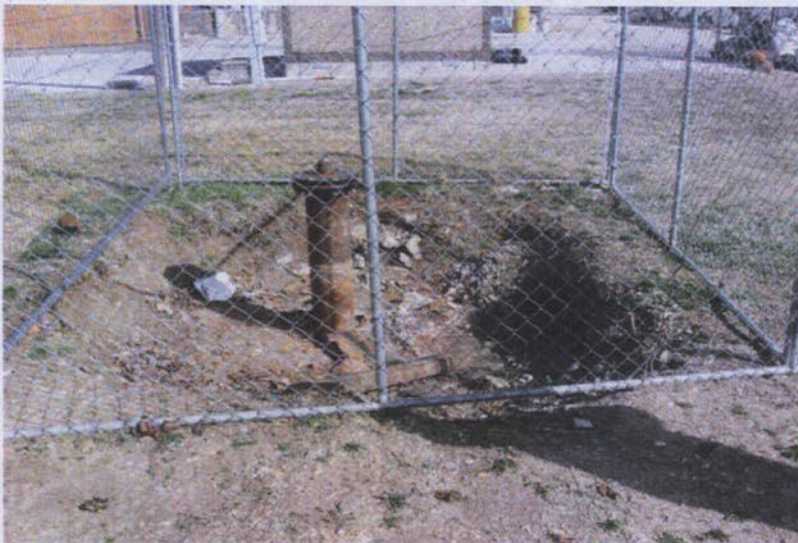
Photograph 8  
Solid State Circuits Site  
Republic, MO  
Photo Taken 03/06/2012  
Candice McGhee,  
DEQ/HWP/SPF

View of CW-1 well within  
fence due to incomplete  
closure of well. Photo  
taken facing North.

<b>OU(s):</b> <b>Sitewide/OU1</b>	<b>Issue Category: Operations and Maintenance</b>			
	<b>Issue:</b> Complete Abandonment and Closure of Republic's CW-1 well			
	<b>Recommendation:</b> Complete the abandonment and closure of the CW-1 well to remove vertical VOC pathway to DBR.			
<b>Affect Current Protectiveness</b>	<b>Affect Future Protectiveness</b>	<b>Implementing Party</b>	<b>Oversight Party</b>	<b>Milestone Date</b>
No	Yes	PRP	State/EPA	06/30/2012

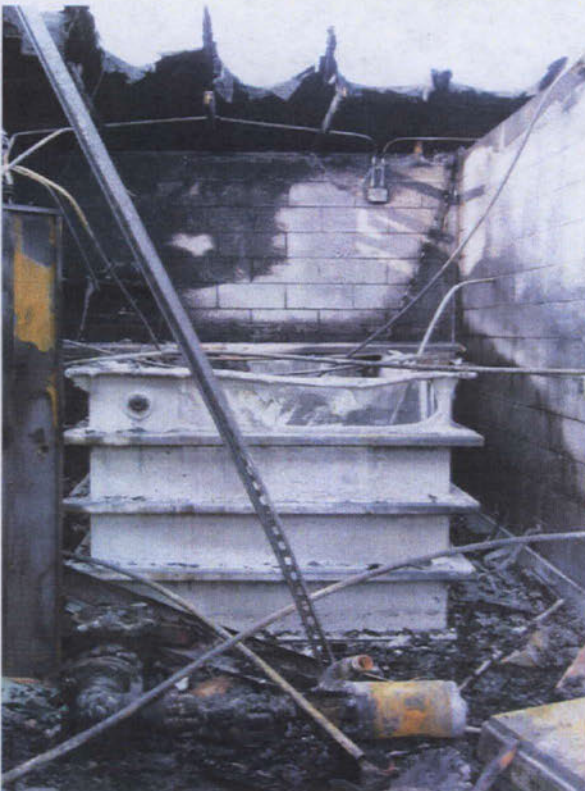
**Photograph 10**

Photo of Equalization Tank  
and debris.

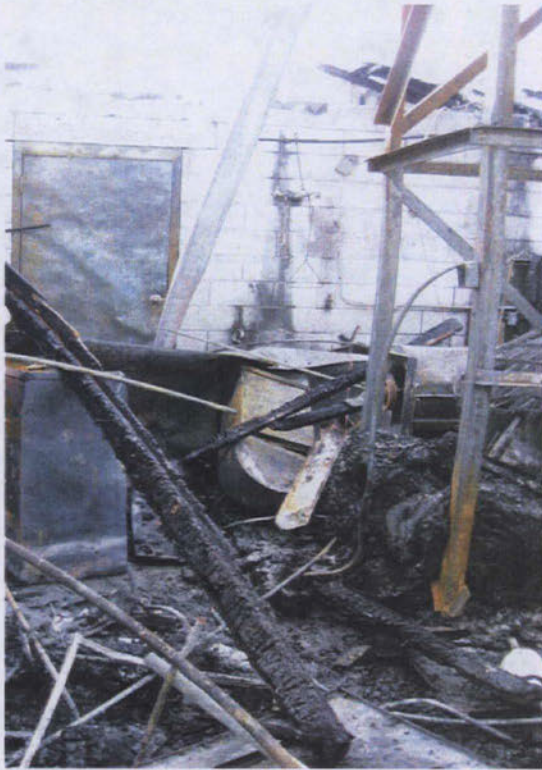
**Photograph 11**

Photo of first air stripper  
and debris. Door to  
Equalization Tank Room.

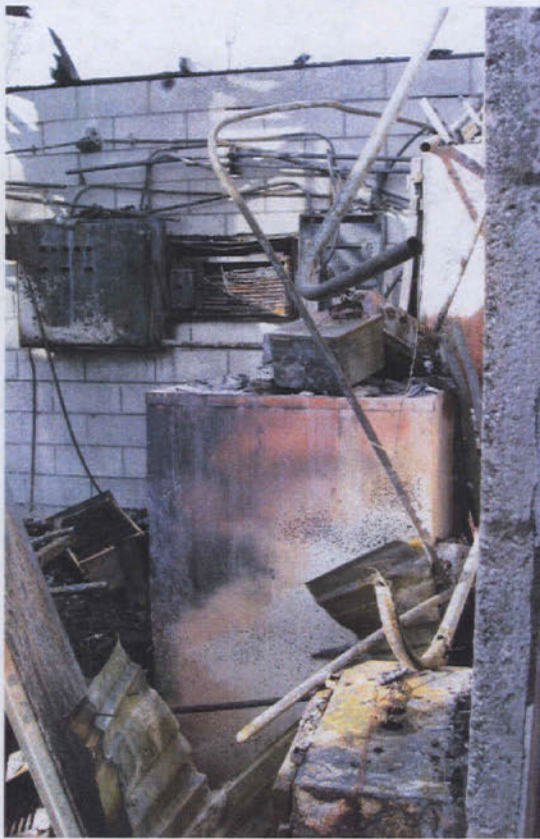
**Photograph 13**

Photo of debris along east  
wall in air stripper room.

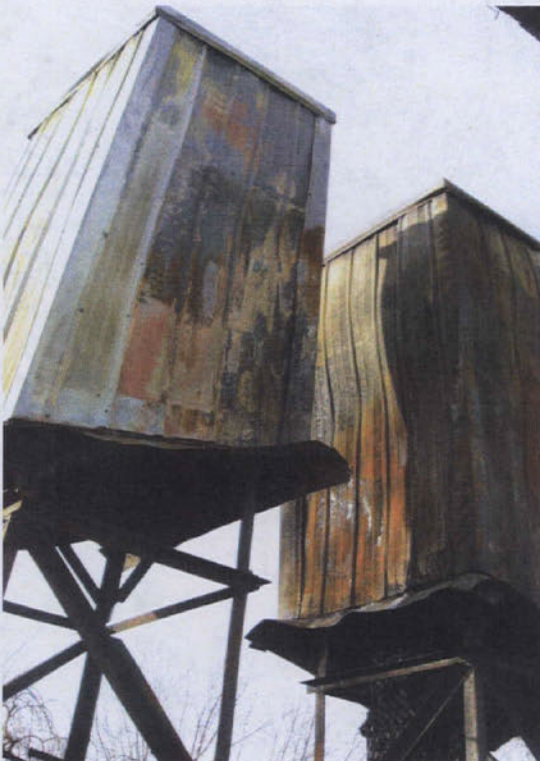
**Photograph 14**

Photo of fire damaged air  
stripper stacks.

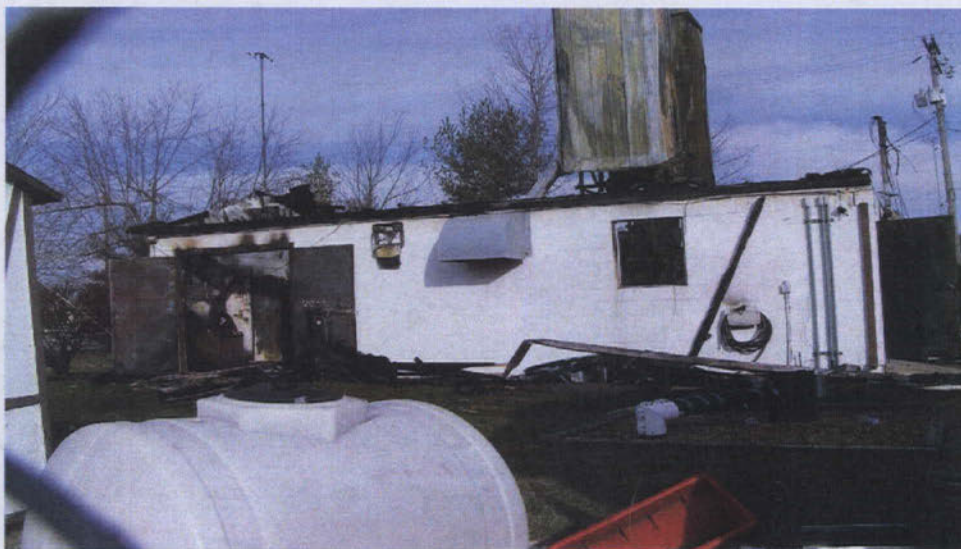
**Photograph 18**

Solid State Circuits Site, Republic, MO  
Date 12/08/2011, Wendell Hall, DEQ, SWRO  
Photo along south side of Air Stripper building with entrance to  
Equalization Room and debris
